Massachusetts Department of Environmental Protection
Bureau of Resource Protection – Watershed Permitting Program
**Sanitary Sewer Overflow (SSO)/Bypass
Notification Form**

Hull, MA WPCF

Unauthorized Discharge Summary to Surface Waters Near 83 Main Street, Hull, MA [3/5/18]

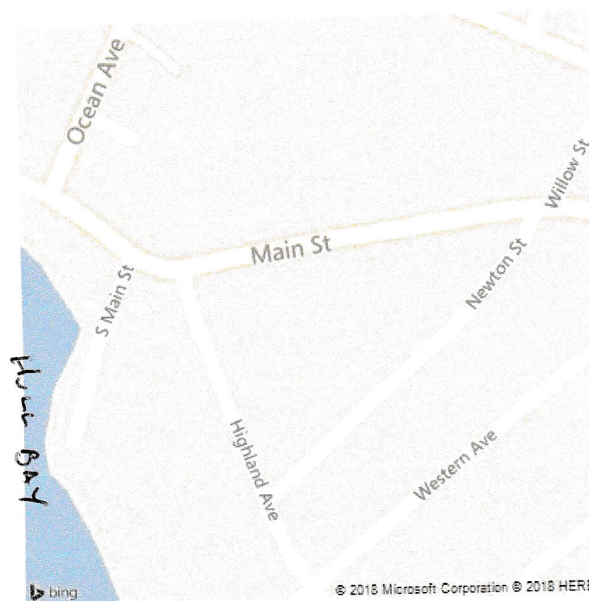
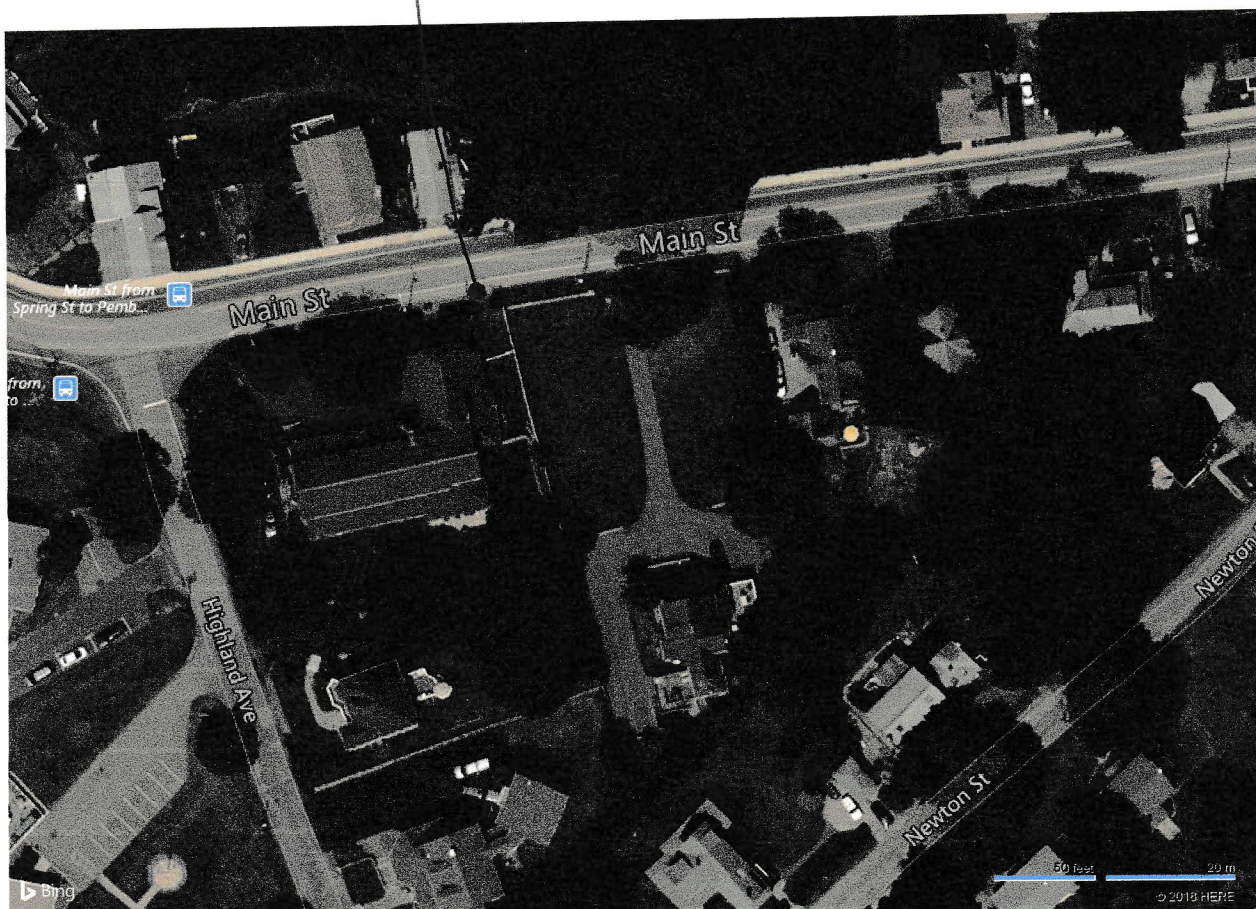
Specify: Leak due to blockage from lateral cleanout on the side of Main Street. Near 83 Main Street, but service connection was from 20 Newton Street

Specify: _____
The leak was inspected by Aram V. and Bill B. on 3/5/18 after reported by John Struzziery. Calls made to a number of drain cleaning companies, and arrangements made for the following morning, since darkness had arrived. Blockage in lateral at curb - specifically at cleanout wye where PVC meets clay pipe. Blockage cleared by "Budge It Drains" on March 6, 2018 at 10:30 am. Truax Corp performed additional cleaning of area on 3/7/18 including two down gradient catch basins.

3/5/18 MAIN ST
 AREA BEFORE CLOG
 WAS CLEARED -
 ALSO SOME RUN-OFF
 FROM RECENT WEATHER
"WRT"

CLEANOUT COVER

CATCH BASIN

Details: Surface area cleaned & washed down. Truax Corp. Vactor truck vacuumed out 2 catch basins and hosed down entire area on 3/7/18.

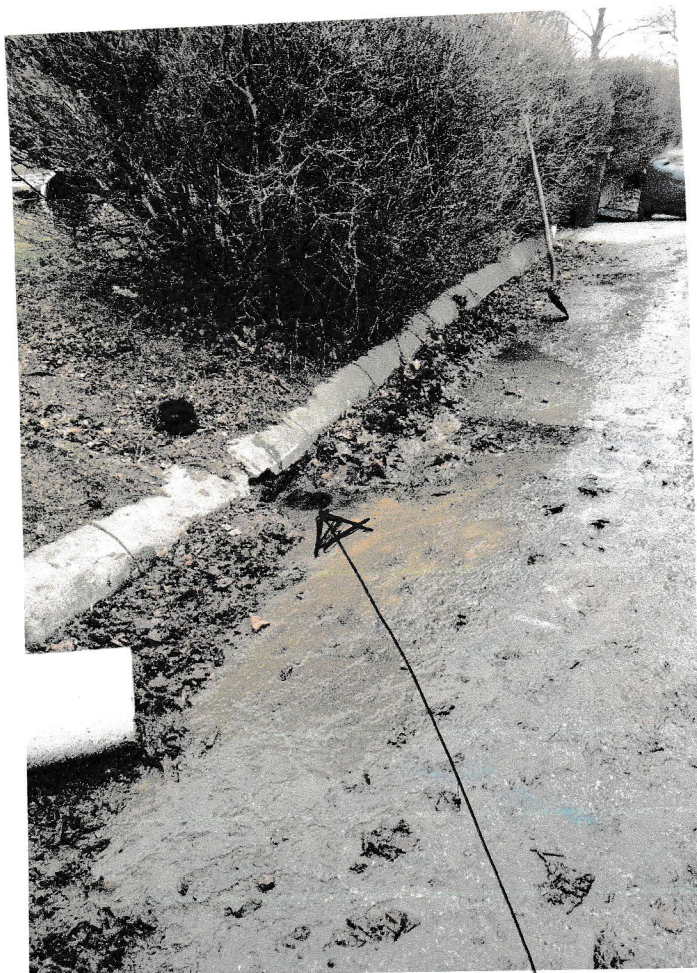
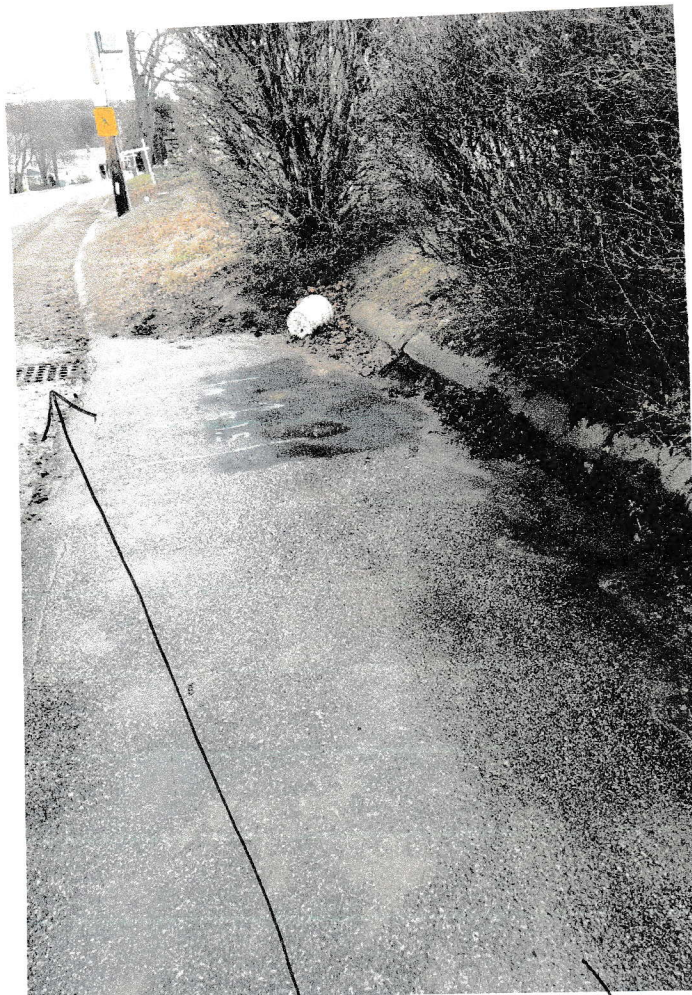
SURFACE AREA
 CLEANED UP
 ON 3/6/18 by
 "Budge IT
 DRAINING"
 After blockage
 cleared
